TECHNICAL REPORT

## Cleanup of Johnston Atoll missile launch facility

AFRI TR88-1

ARMED FORCES RADIOBIOLOGY RESEARCH INSTITUTE

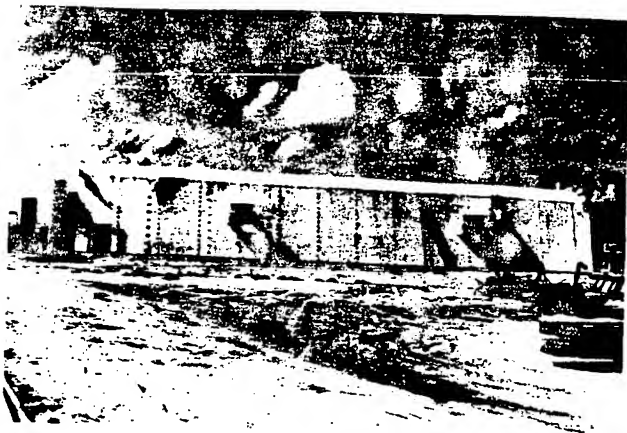
Figure 6. Missile shelter building before disassembly

To ensure that the nonsalvageable contaminated materials met the DoT and storage-site requirements, the structures on the Launch Emplacement Site 1 (excluding the concrete pads) were first disassembled and cut into workable sizes (Figures 6 and 7). When possible, the debris was cut into pieces about 6 feet by 8 feet to conserve space in the freight containers. Because there were so many different types of debris (pipes, cabling, ladders, railroad ties, etc.), the sizes of the cut pieces varied greatly. Each piece was then cleaned and painted. The debris was painted to effectively fix any remaining contamination in place, meeting the DoT requirement that there be no loose contaminants. The loose Gunite concrete could be broken up into workable pieces and processed in the same manner as the structural debris. However, it was not practical to remove the massive concrete pads. Instead, only the contaminated surfaces were removed through a process called scabbling, in which the top layers were chipped away. That material was then stored in 55-gallon drums. The scabbling process, described below, resulted in rubble whose contamination was uniformly distributed. Before

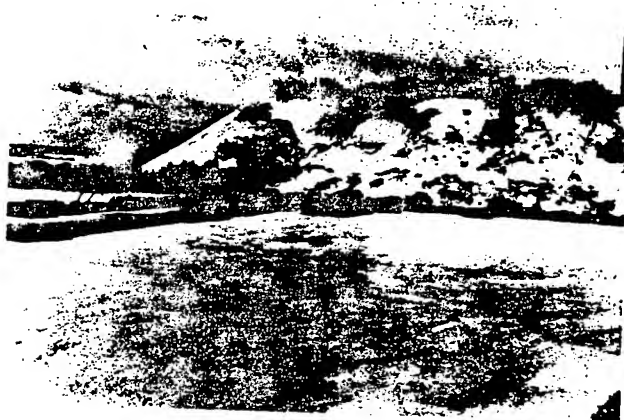
Figure 12. Debris laid out in rows at counting area

The counting area was about 800 feet east of the launch site and was chosen for its relatively low background radiation. When the pallets reached the counting area, they were laid out in rows (Figure 12), and each piece of debris was numbered (Figure 13). To locate areas with high levels of contamination, a preliminary

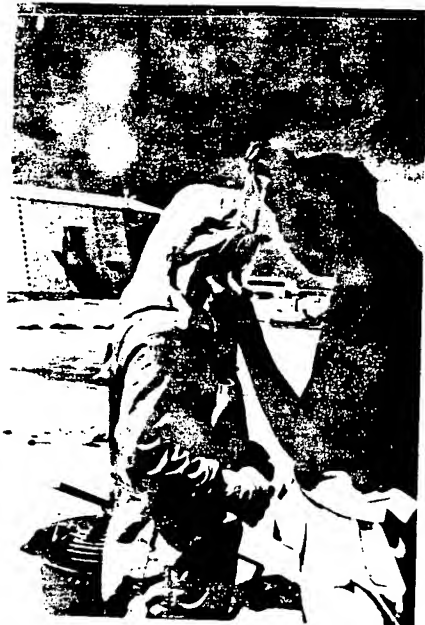
Figure 15. Removing respirators at contamination hot line: Note use of full anticontamination clothing

The major radiological danger throughout the operation was the possibility of inhaling alpha-emitting actinide particles. For this reason, strict radiological control procedures were maintained. Full anticontamination clothing and respirators (Figure 15) and full-body monitoring with alpha detectors at the hot line contributed to a successful program. The airborne contamination hazard normally associated with winds was mitigated because of the heaviness of the plutonium contaminant. Air monitors were run continuously at 30, 50, and 100 meters downwind of the site. These read as high as 50 fCi/m<sup>3</sup> averaged over a 24-hour period. As expected, they gave high readings when there was activity that involved mixing up the debris (such as torching, cutting, and scabbling) and low readings (tens of fCi/cm<sup>3</sup>) when there was not much activity. The air monitors upwind of the site typically read 10-50 fCi/cm<sup>3</sup>.
